# **Service Center**

## FY 2011 - 2020

## **TEN-YEAR SITE PLAN (TYSP)**

U.S. DOE – NNSA Service Center

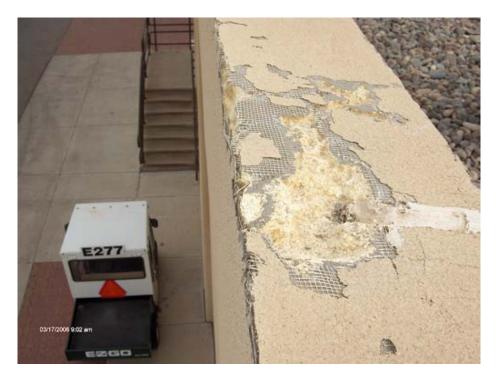
Figure A-1: Example of Typical Damaged Parapet

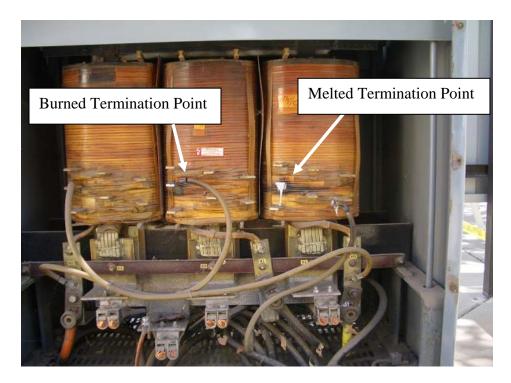
Figure A-1: Example of a Step Down Transformer Fault (Single Point Failure)
